Second Five-Year Review Report

Former Naval Construction Battalion Center Davisville North Kingstown, Rhode Island

March 2008

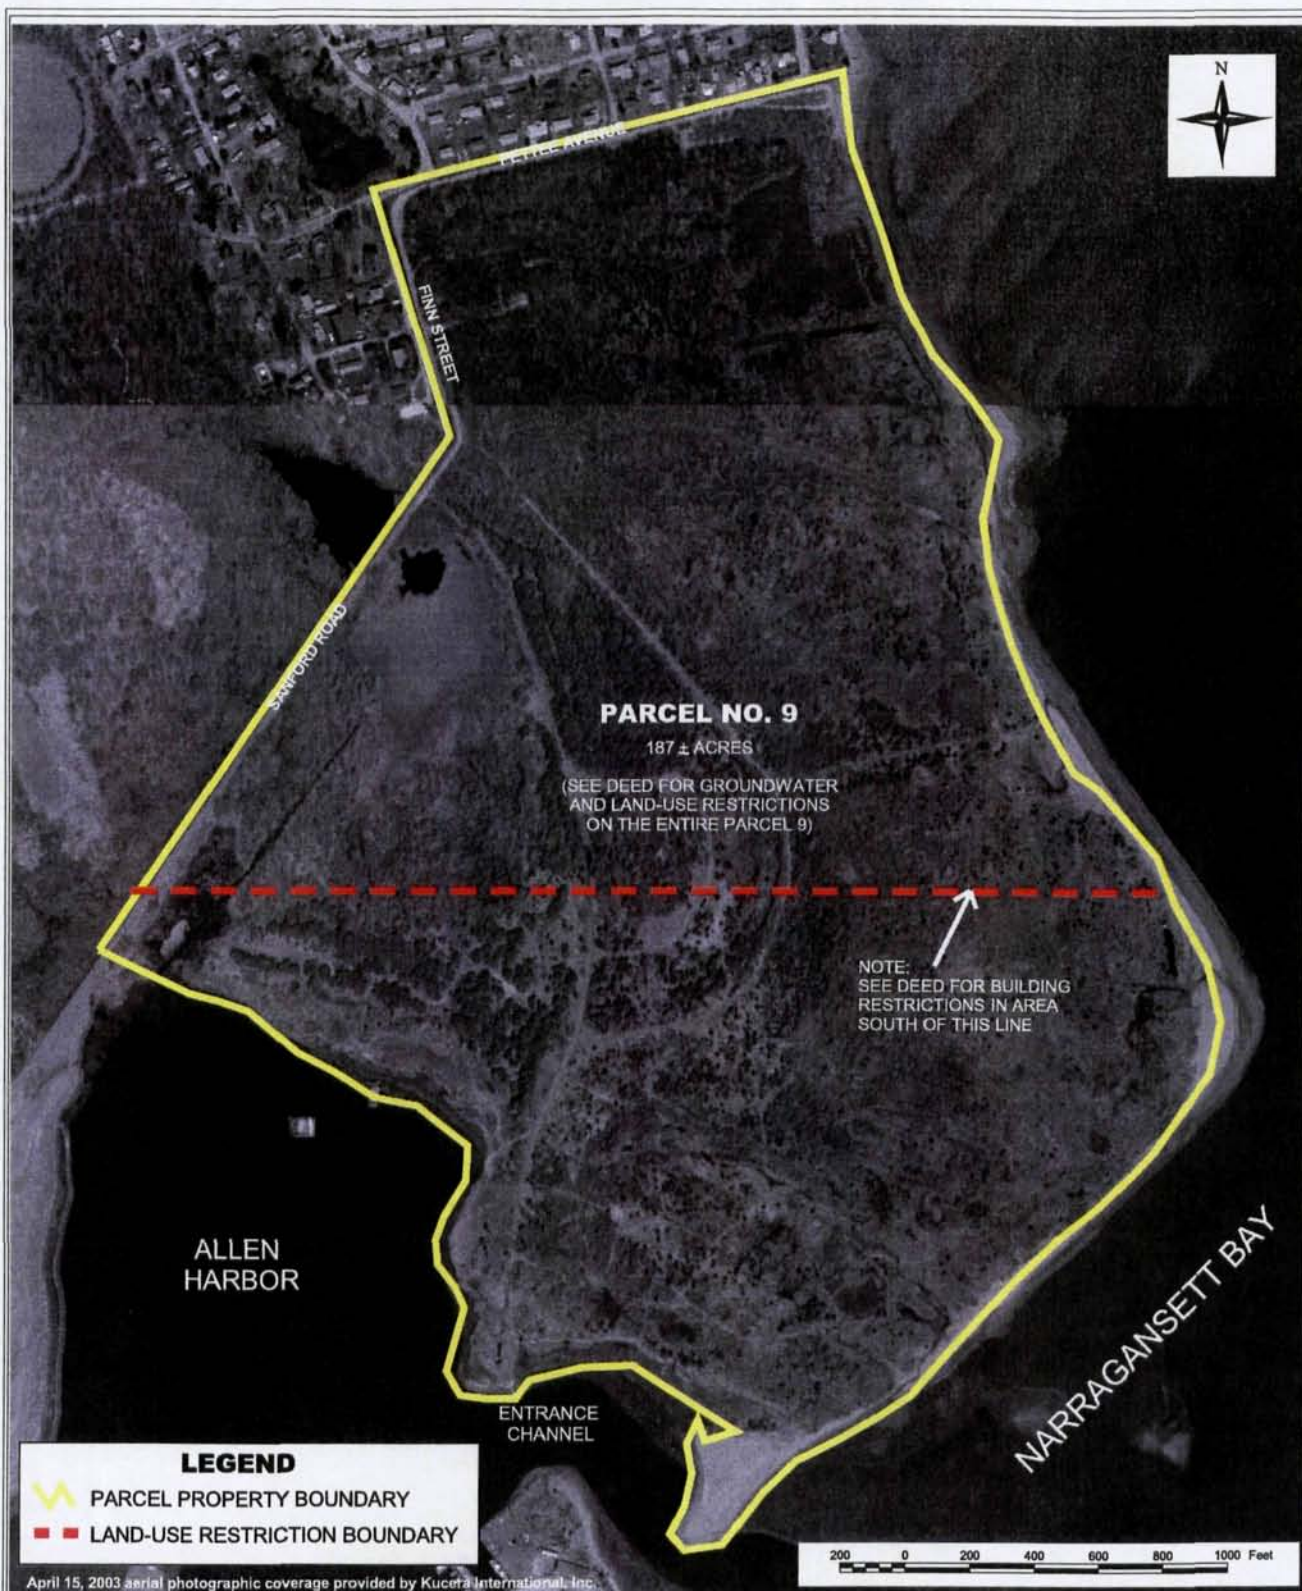
FIGURE NUMBER
FIGURE 2-3

**PARCEL NO. 9 SITE MAP
SECOND FIVE YEAR REVIEW
FORMER NCBC DAVISVILLE
NORTH KINGSTOWN, RHODE ISLAND**

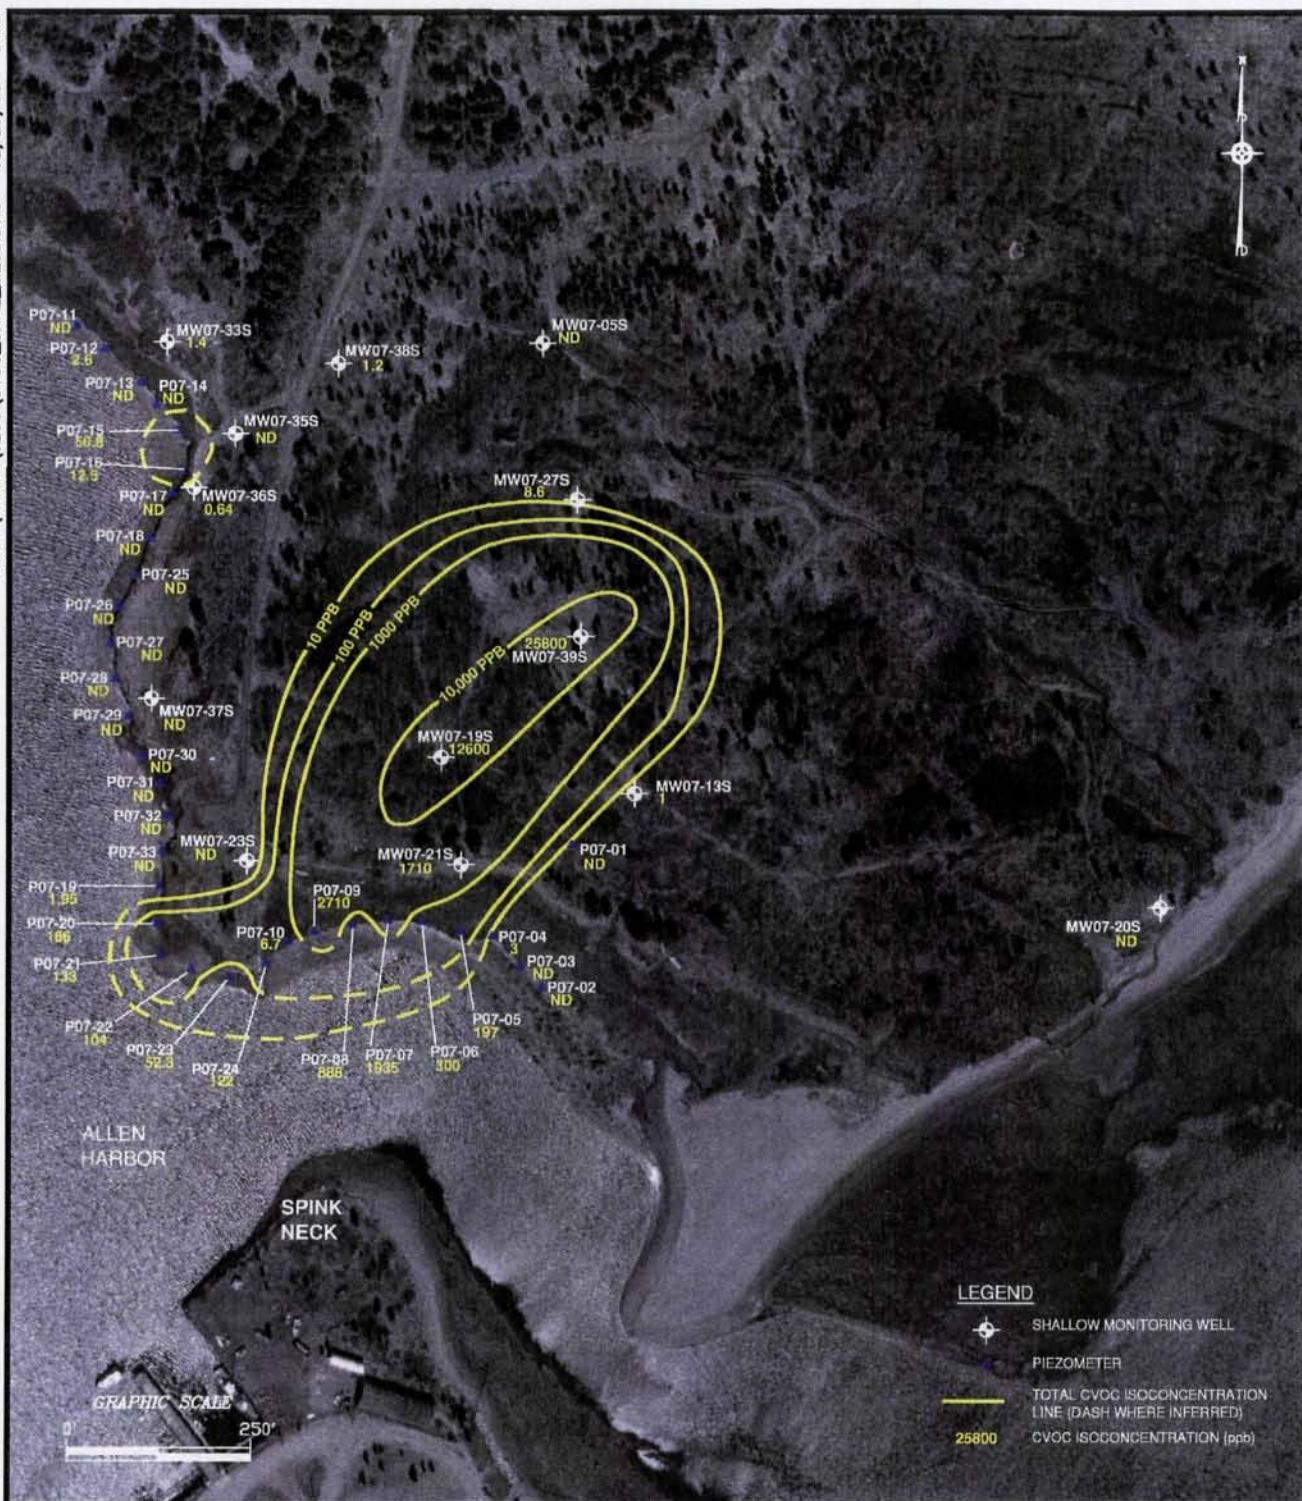
FIGURE NUMBER
2-4

TOTAL CVOCs DETECTED IN SHALLOW GROUNDWATER MONITORING WELLS
MONITORING EVENT 08 - FEBRUARY/MARCH 2007
SITE 07, NCBC DAVISVILLE
NORTH KINGSTOWN, RHODE ISLAND
